MICROSCOPY INVESTIGATION ON DIFFERENT MATERIALS AFTER PULSED HIGH FIELD CONDITIONING AND LOW ENERGY H⁻ IRRADIATION

Abstract

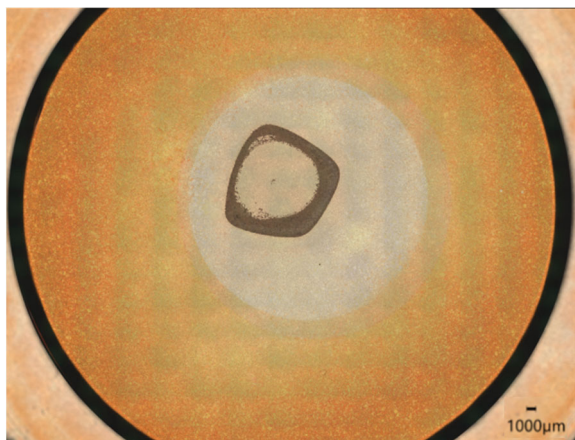
These blisters are concentrated on the impact zone. It is visible that the areas where we had the maximum deposition of beam the blisters have a higher density in quantity comparing with zones where the beam was less intense.

Figure 1: Optical microscope picture using 50x lens, including all the surface of the Cu cathode after irradiation and before performing tests with high energy pulsing.

In Fig. 1 it can be seen an optical picture of all the surface of the electrode where is visible the result of the beam

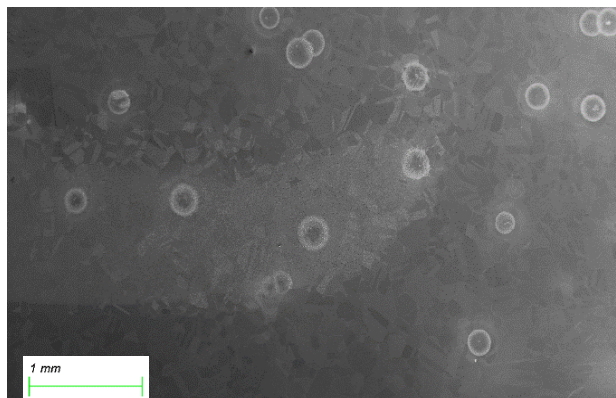
Figure 2: SEM imaging, using secondary electron detector, showing partially the transition zone (the irradiated zone corresponds to the zone less dark) and some of the breakdowns provoked by the high energy pulsing.

We can observe from Fig. 2 that the breakdowns are well distributed on the surface and do not seem to be correlated with the irradiated zone (zone less dark due to the blistering effect). Figure 3 shows a breakdown in the transition zone. We have designated transition zone for the area where we start to see a decrease of density of blistering. In this zone it is visible that only some grains are affected by blisters. The fact that the phenomenon of blistering is more evident in just some of the grains may be correlated with the grain orientation of the material. Additional studies will be performed to understand this correlation.

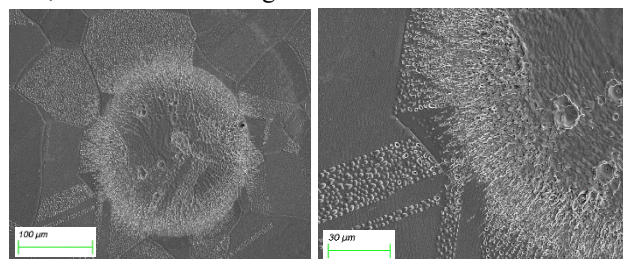
Figure 3: SEM imaging with different magnification, using secondary electron detector, showing a breakdown in the transition zone of the electrode.

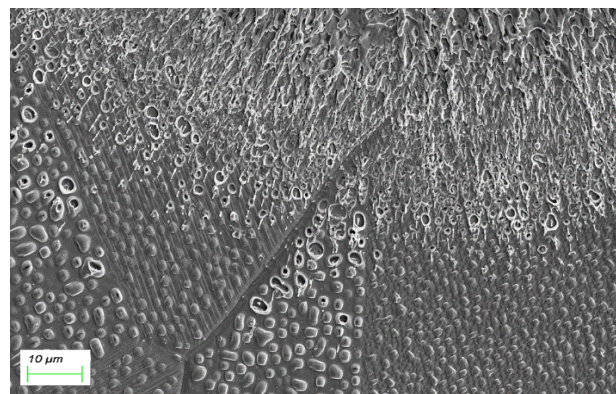
The breakdowns have a circular shape with approximately 200 μm with splashes of melted material on their surroundings. The heat provoked by the breakdowns have shown to be significant enough to destroy some of the blisters close to it, as we can see in Fig. 4.

Figure 4: SEM imaging, using secondary electron detector, showing the effect of the breakdown on the surrounding blisters that were present on the surface.

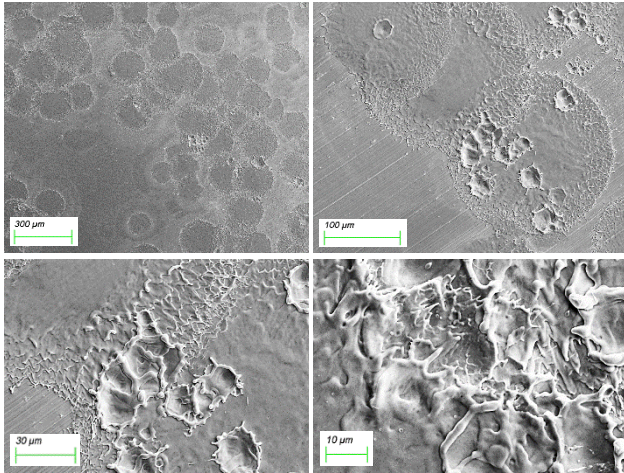
Figure 5 shows the breakdowns on the TiAl6V4 irradiated cathode on the surface. Concerning the LES experiment after irradiation, the TiAl6V4 electrodes have reached a stable field of 90 MV/m [4].

Also, for this material we have seen a slight decrease of breakdown performance due to irradiation - the pair of TiAl6V4 non-irradiated electrodes that was tested in the LES system reached the average value of 100 MV/m [4].

Figure 5: SEM imaging with different magnification, using secondary electron detector, showing the breakdowns triggered by the LES experiment, on the TiAl6V4 irradiated cathode.

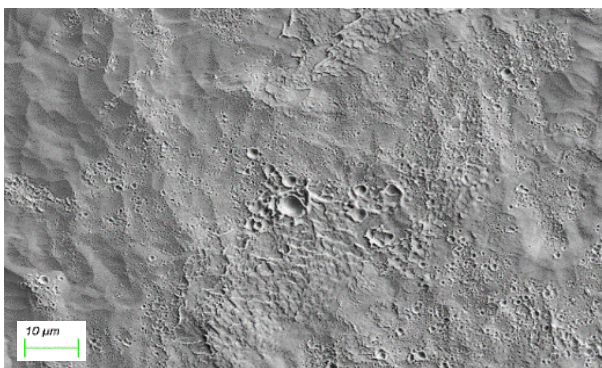
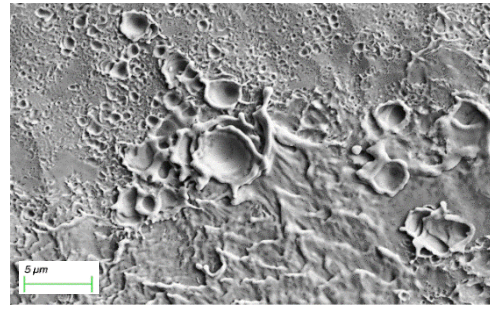
Figures 6 and 7 show some breakdowns on the Nb irradiated electrode. The breakdowns are smaller and less deep when comparing with the Cu-OFE and TiAl6V4 electrodes. For the Nb material, the electrodes have reached an average field of 22 MV/m in the LES system, after irradiation. The second pair of electrodes which was not irradiated have reached a field in the LES system of 80 MV/m [4]. The considerable difference in the fields values seems to have been caused by effects from the irradiation experiment. However, microscopy observations have shown no particular features in the surface or blistering effects that can be correlated with the decrease of performance, and investigations are ongoing to ascertain if this can be attributed to chemical surface modifications.

Figure 6: SEM imaging showing the breakdowns triggered by the LES experiment, on the Nb irradiated cathode, using secondary electron detector.

Figure 7: SEM imaging showing the breakdowns triggered by the LES experiment, on the Nb irradiated cathode, using secondary electron detector.
