First Years of Linac4 RF Operation

Suitbert Ramberger on behalf of the CERN RF group, and with the support of Rolf Wegner

29 August 2022

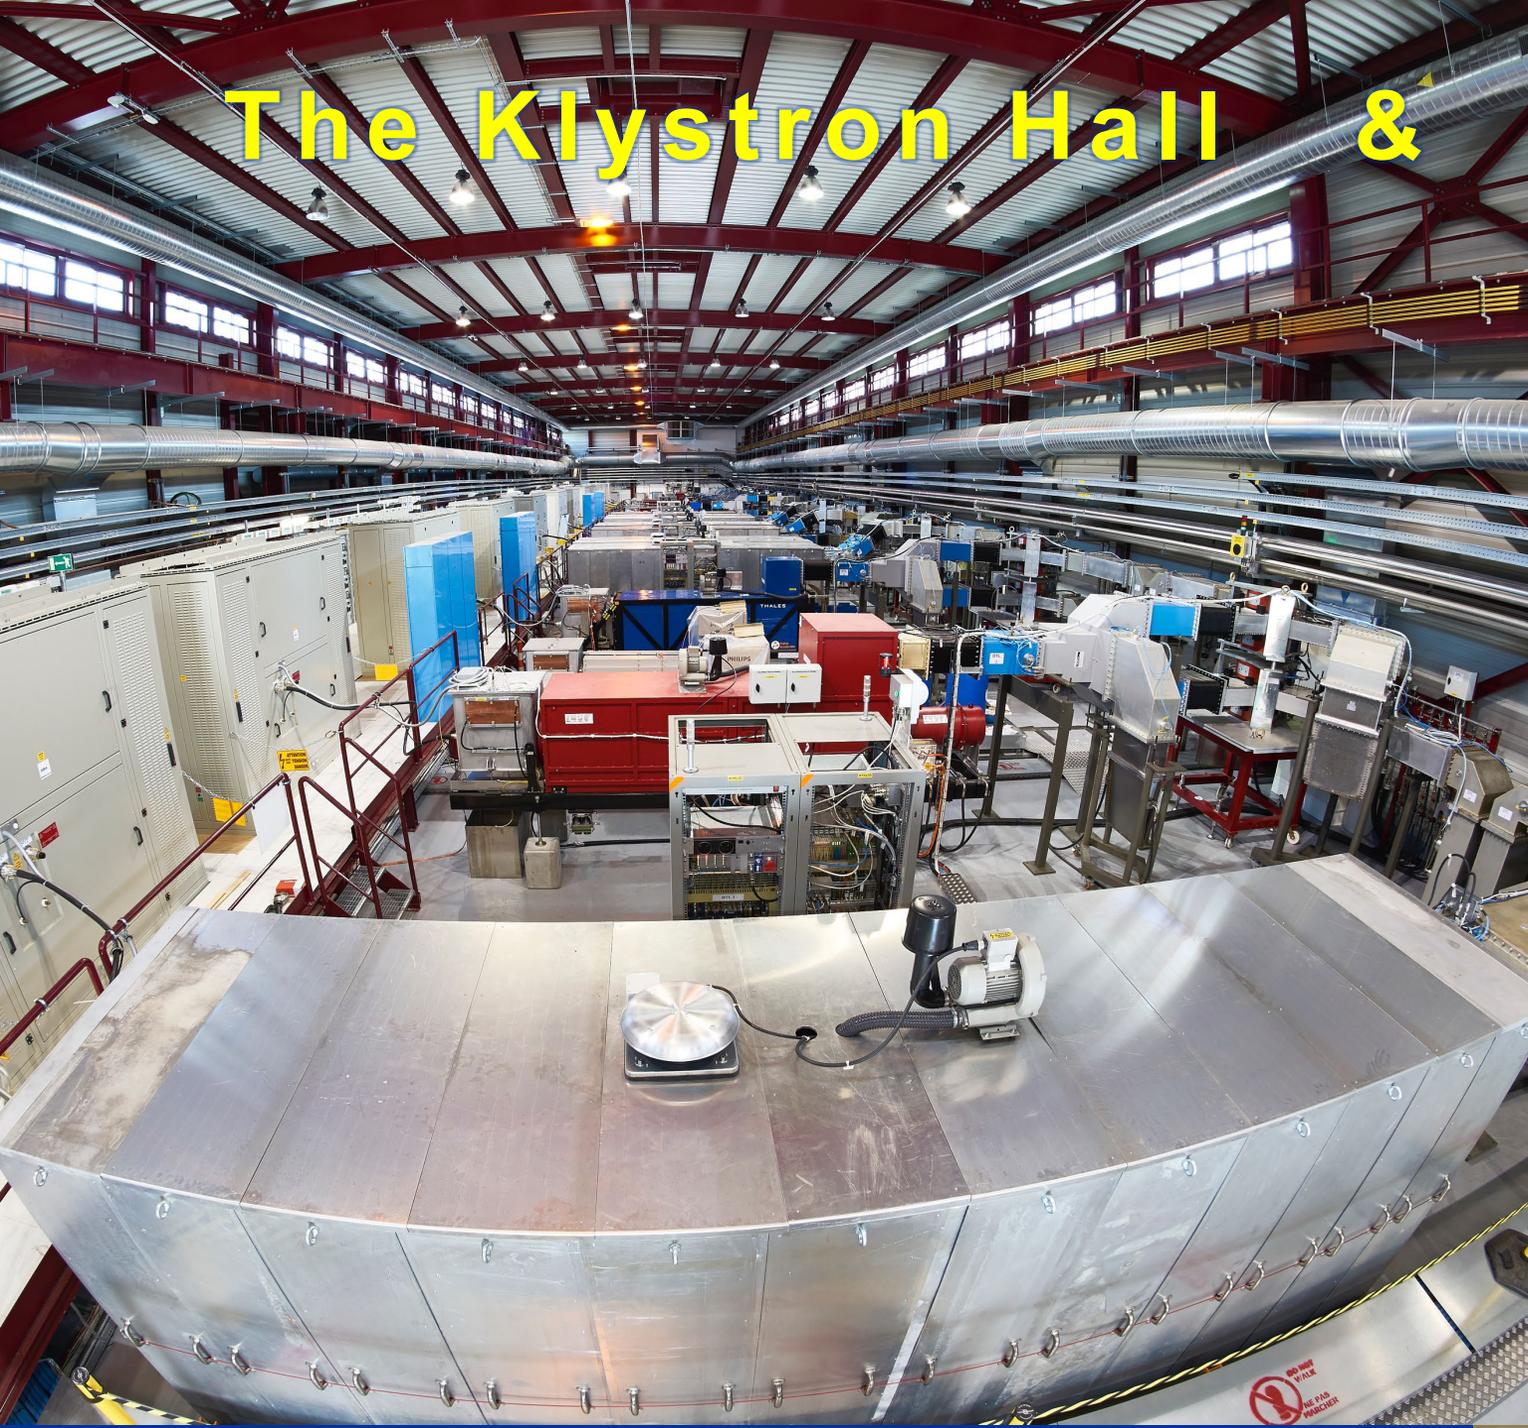
The Klystron Hall &

100 m x 12 m
12 m above tunnel
352.2 MHz
7x 1.3 MW LEP Klystrons
9x 2.8 MW HP Klystrons
110 kV Modulators
Faraday cage for LLRF

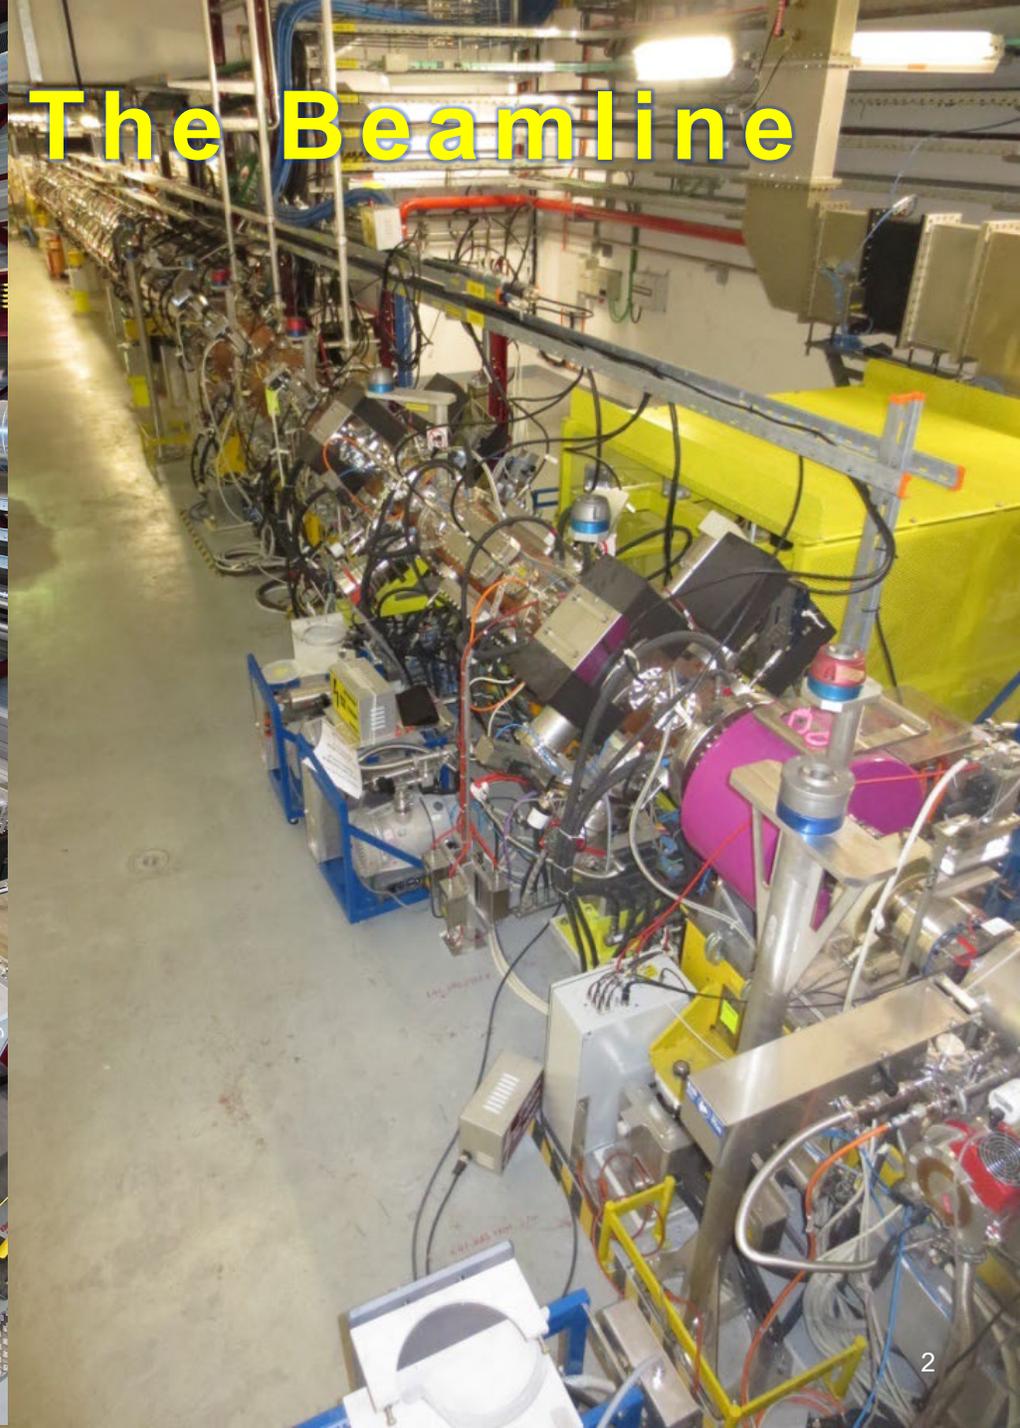
The Beamline

80 m
160 MeV
0.3 π mm mrad
17...23 mA (in Op.)
4x150 μ s
1.2 s repetition
0.08% duty cycle

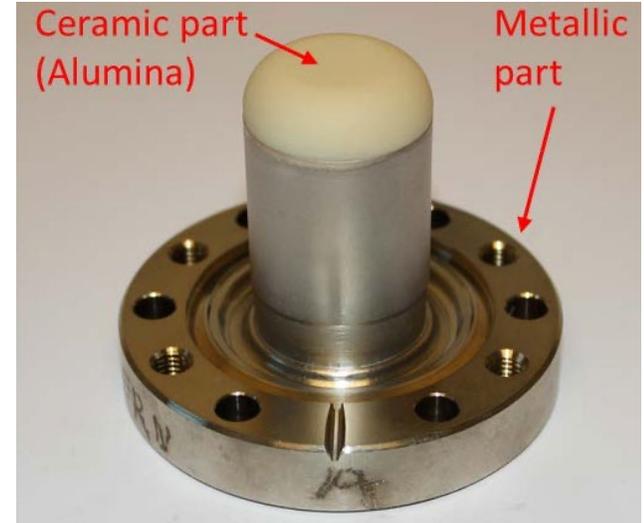
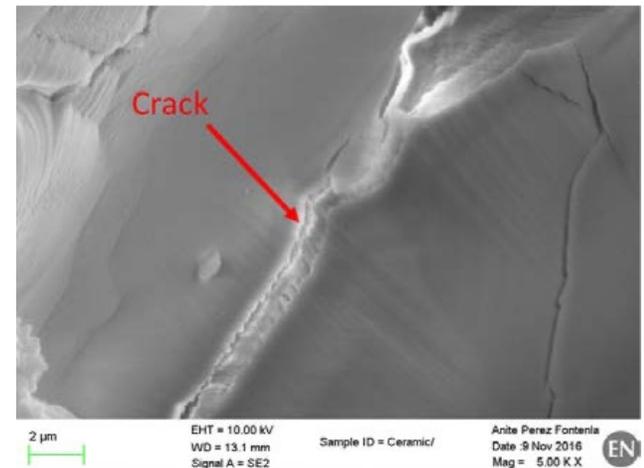
RF probe windows damaged by breakdowns

- Sporadic failures with vacuum leaks during conditioning
- Became more and more regular with operation
- Breakdown activity damages the ceramic vacuum window
- Pattern: Big cavities showed more issues than smaller ones
- Correlated with cavity stored energy (24J on DTL Tank3)
- Material tests before and after confirmed breakage of ceramic.

- Redesign of RF probes with retracted commercial coaxial feedthrough
- Some RF probes are calibrated. Required coordinated exchange
- Since then no vacuum leak

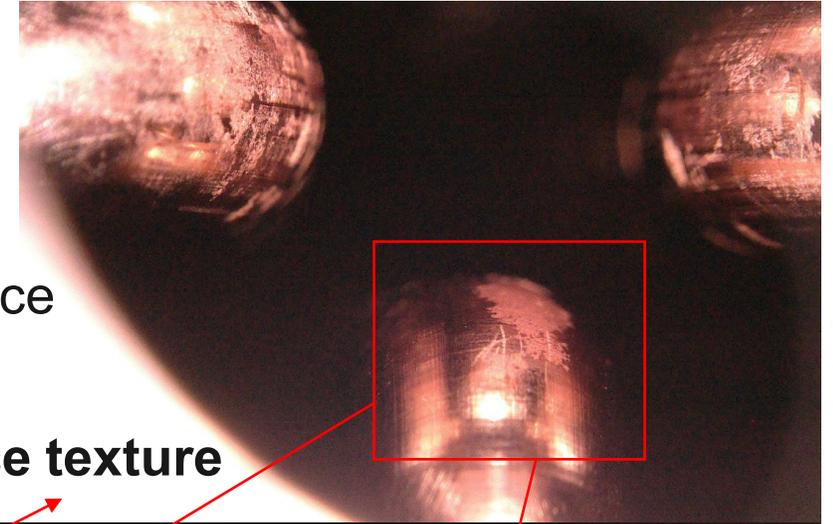
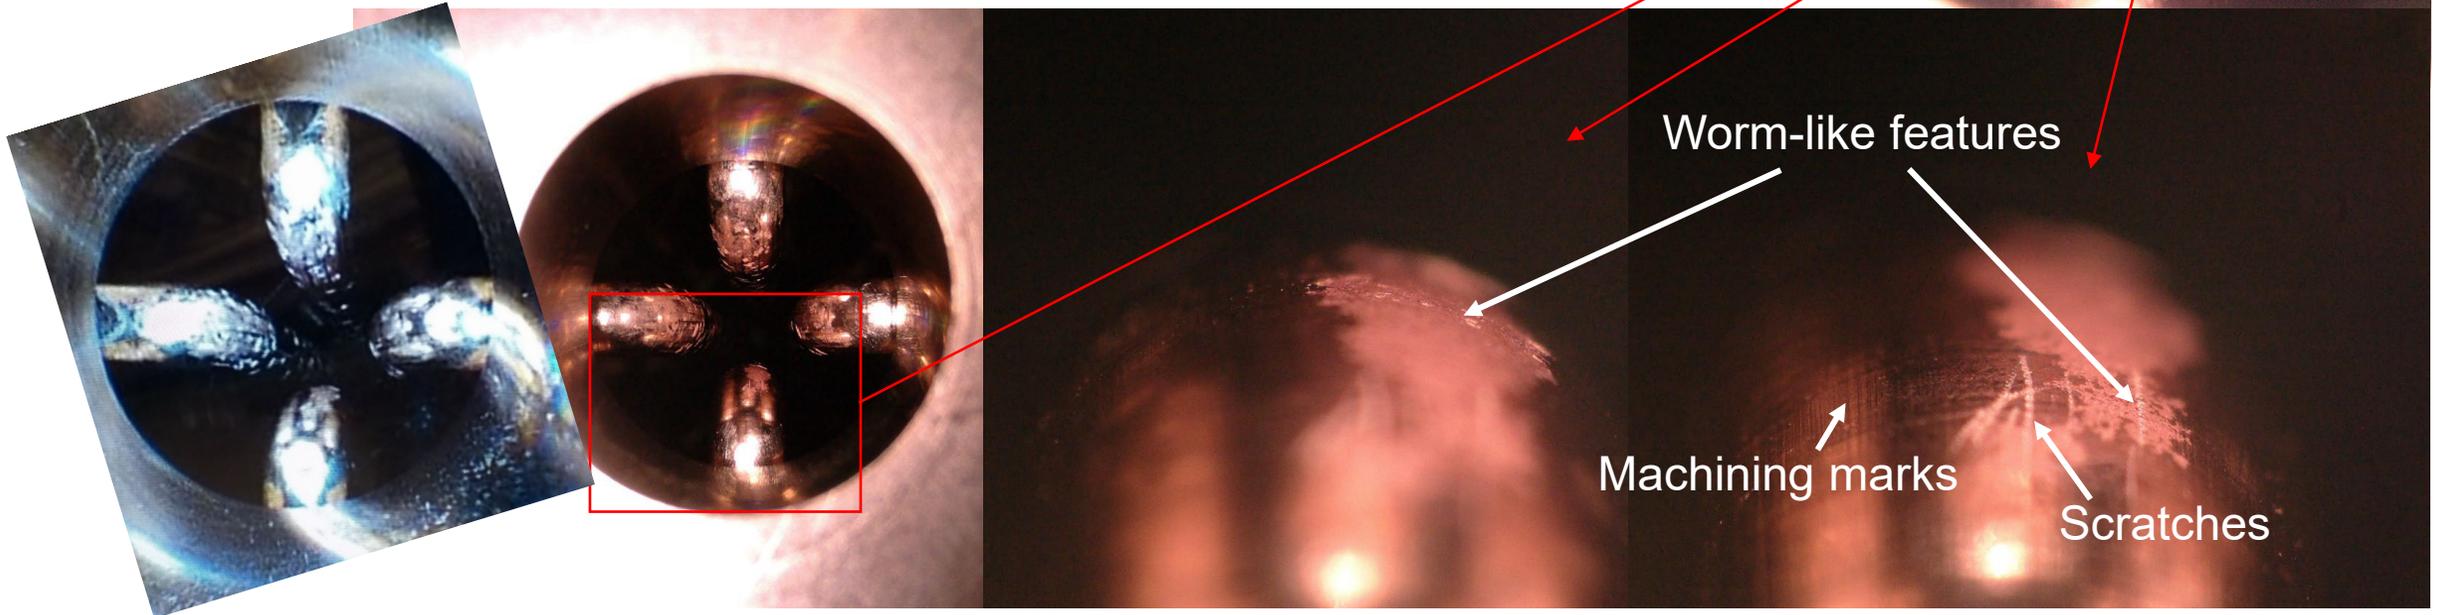
The Inspection

- RFQ1 endoscopy inspection on 7 and 8 January 2020:
- Various worrying images – but **impossible to judge** the relevance
- RFQ1 direct camera inspection on 1 February 2020:
- Presumed damage turned out to be mostly **variations in surface texture**

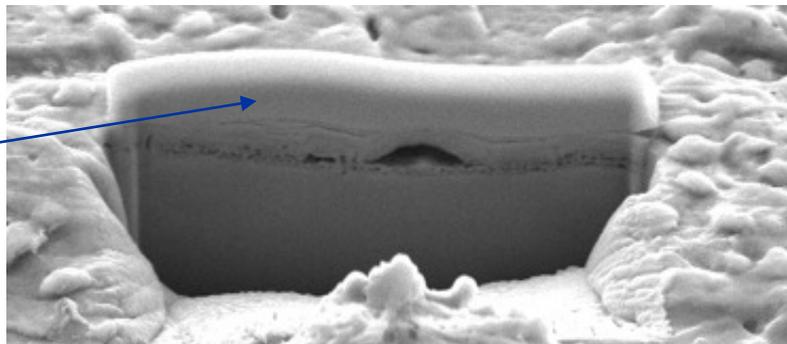
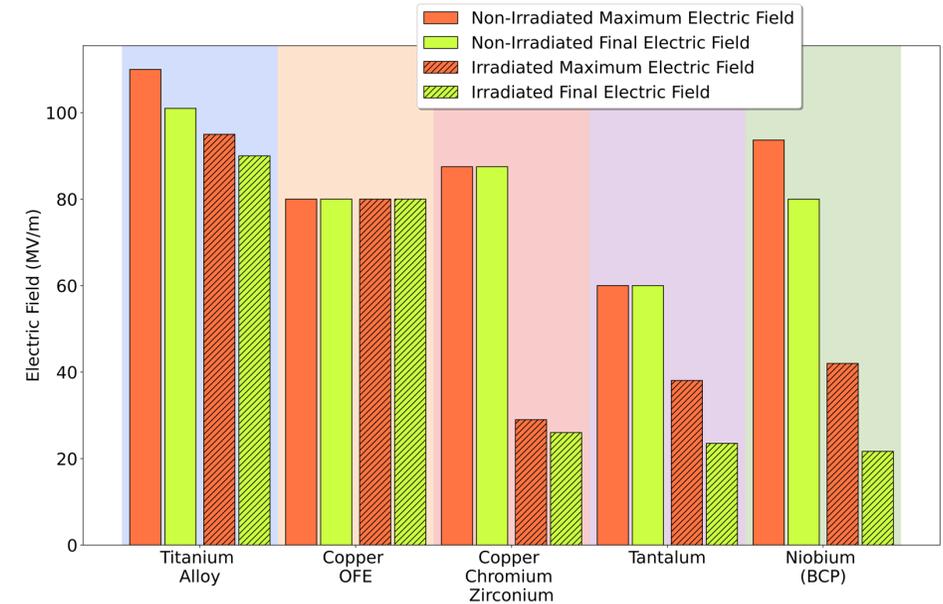
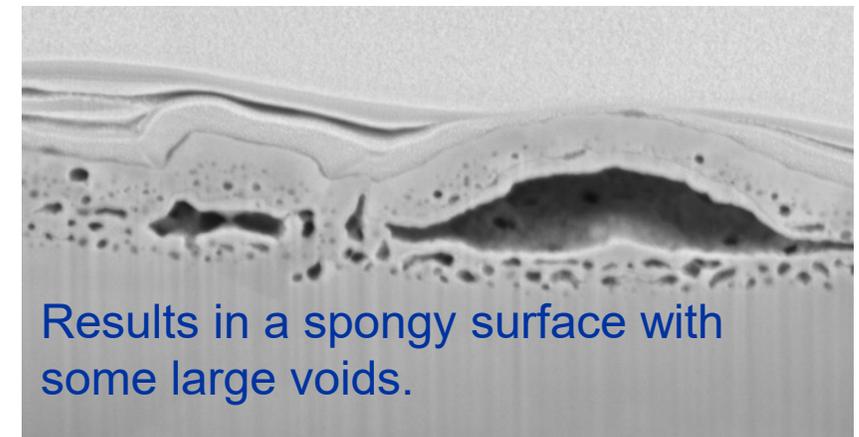
The Material Studies

- Hydrogen implantation into copper
- In OFE-Cu samples accumulates in bubbles
- Process of blistering as reported in literature
- Seen as change of surface texture
- Material irradiation/breakdown test programme
- Effect on breakdown statistics studied

Pt deposit to protect the surface during ion milling

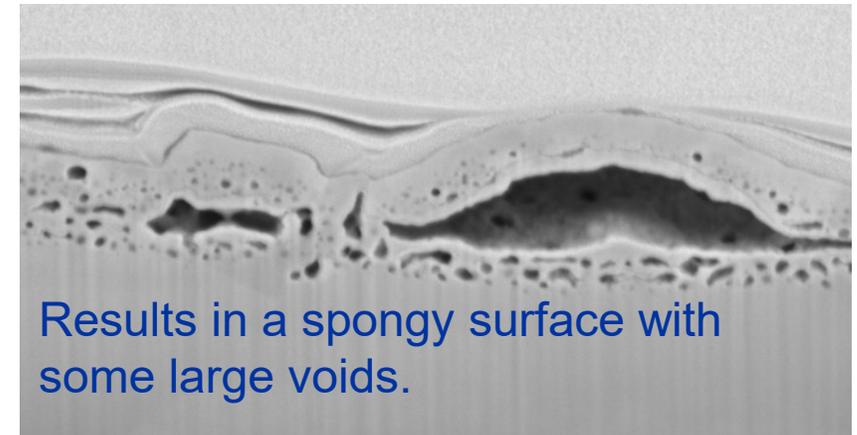
The Material Studies

- Hydrogen
- In OFE-C
- Process of blistering as reported in literature
- Seen as
- Material i
- Effect on breakdown statistics studied

C. Serafim et al., “Microscopy Investigation on Different Materials after Pulsed High-Field Conditioning and Low Energy H-”, TUPOPA06, this conference, 2022.

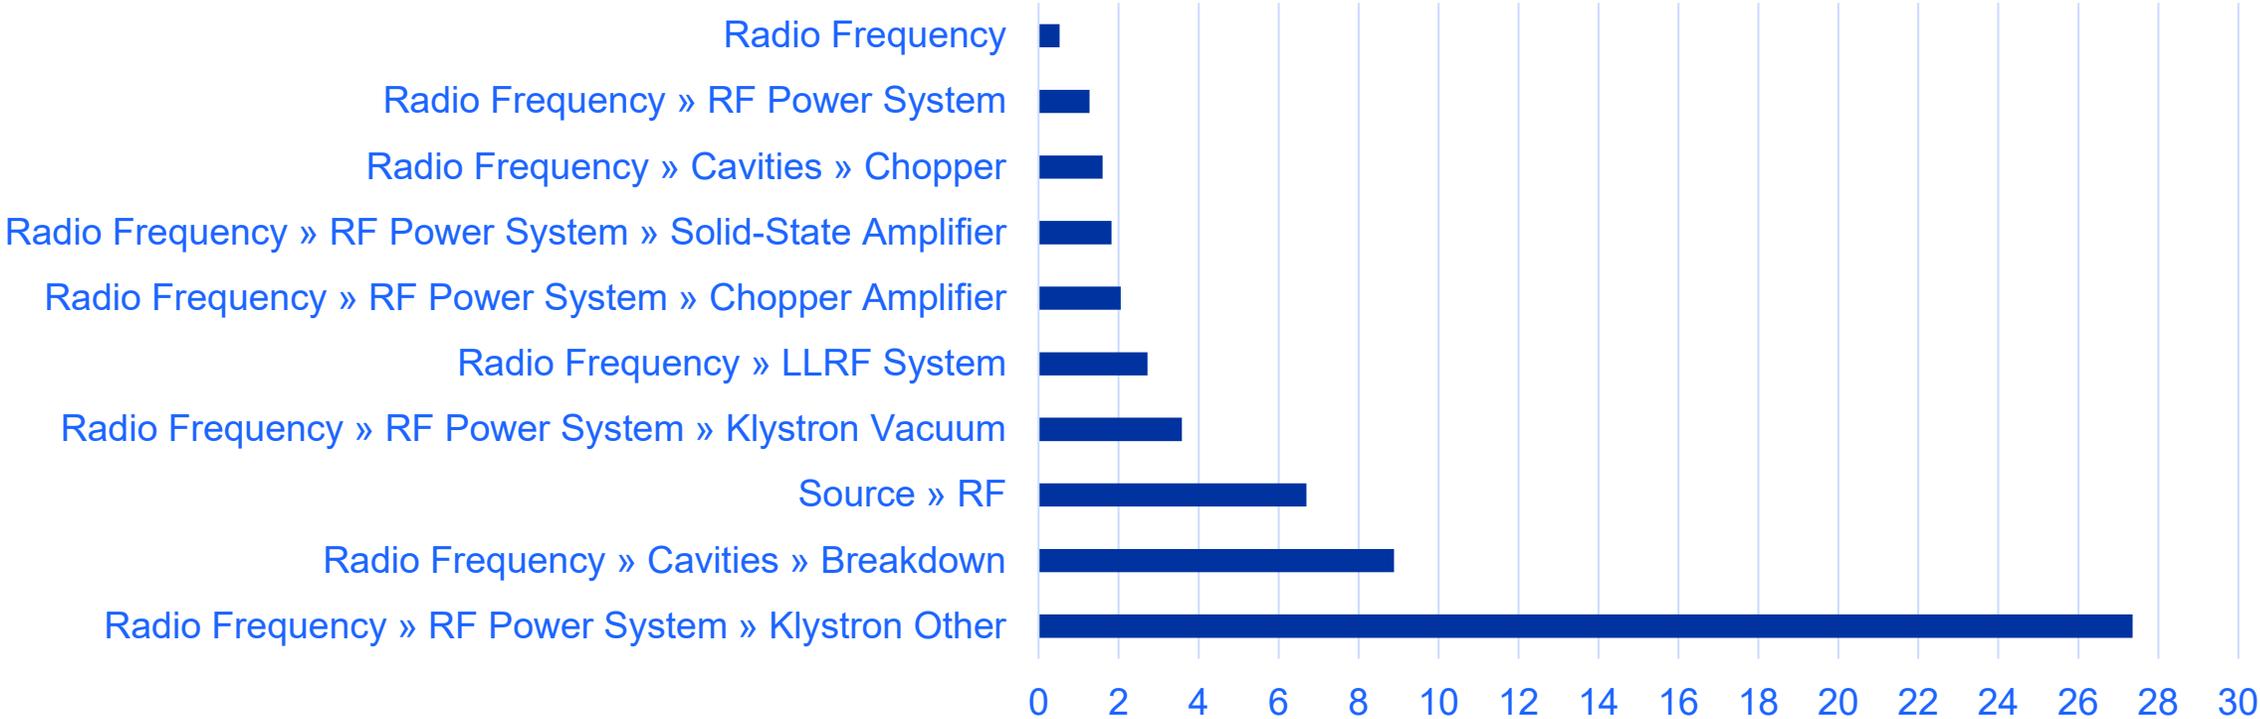
Root Fault Time (in hours) by RF System in 2022 (until August)

- Most faults are on HV systems and many of these are due to high field breakdown
- New chopper driver & source solid-state amplifier studied. LEP klystron replacements in due time.
